Evaluation of the durability of the exterior siding products made with trembling aspen lumber in terms of colour change

Mengyuan Zhang^a, Dawei Wang^{a,b}, Meng Gong^{a,*}, Ying-Hei Chui^{b,*}

^aWood Science and Technology Centre, University of New Brunswick, 1350 Regent St., Fredericton, NB, E3C 2G6, Canada

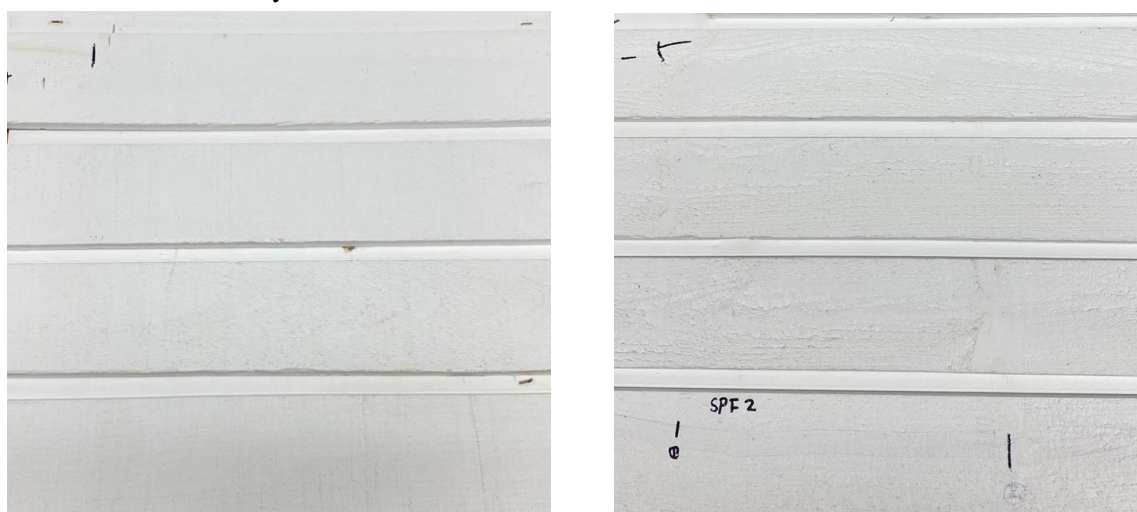
Fig. 1. Finished exterior siding specimens made of trembling aspen (left) and S-P-F (right).

mm (1.4 in.) in width, and 2,590 mm (8.5 ft.) in length. All siding specimens featured a “channel” profile (**Fig. 1**). For comparative purposes, both finished and unfinished specimens of trembling aspen and S-P-F were included in this study. Each test included an equal number of finished and unfinished specimens for consistency.

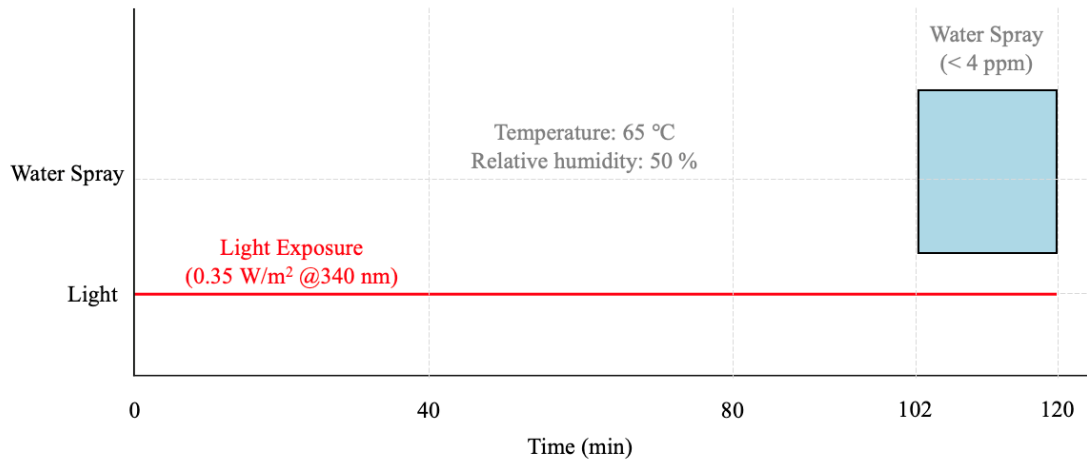
Fig. 6. Schematic of a complete single weathering treatment cycle in this study.

Fig. 6 illustrates a complete test cycle based on ASTM G155. A complete cycle of the accelerated weathering procedure spanned 120 minutes, consisting of 102 minutes under light exposure and 18

minutes of light combined with water spraying. The full test consisted of 1,000 cycles, totalling 2,000 hours, with exposure conditions detailed in **Table 2**. To monitor and assess changes throughout the testing process, the specimens were periodically taken out for measurements of colour, mass, and dimensions at intervals of 50, 250, 500, 1,000, and 1,500 hours. To ensure the accuracy of the experimental results, the equipment was calibrated every 200 hours during the testing process. After exposure, all the specimens were evaluated based on changes in colour and the occurrence of checks in wood. The colour was recorded using the colourimeter.

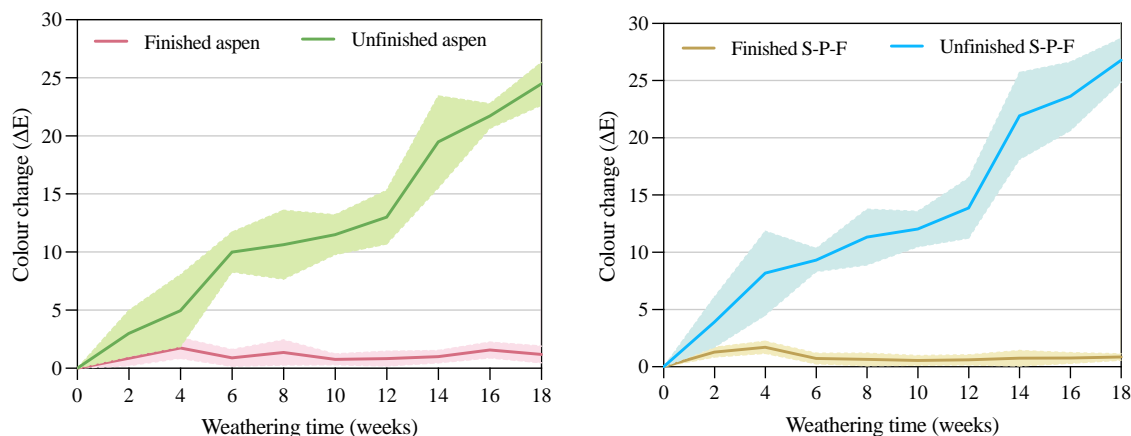
Fig. 8. The time-dependent weathering curves of average colour changes (ΔE) of wood siding specimens: (upper) trembling aspen and (lower) S-P-F.

Fig. 8 illustrates the variation in average colour change (ΔE) for trembling aspen and S-P-F specimens at 6, 12, and 18 weeks of weathering. In both species, finished specimens exhibited the smallest ΔE after 18 weeks, confirming the effectiveness of surface finishing in reducing discolouration. Trembling aspen demonstrated greater average colour stability than S-P-F throughout the test period. At week 18, the average colour change of unfinished S-P-F reached approximately 27.4, which was 3.0 higher than that of unfinished aspen (24.4). Among finished specimens, aspen also showed better performance, with an average colour change of 10.5, which was 1.5 lower than that of finished S-P-F, measured at 12.0.

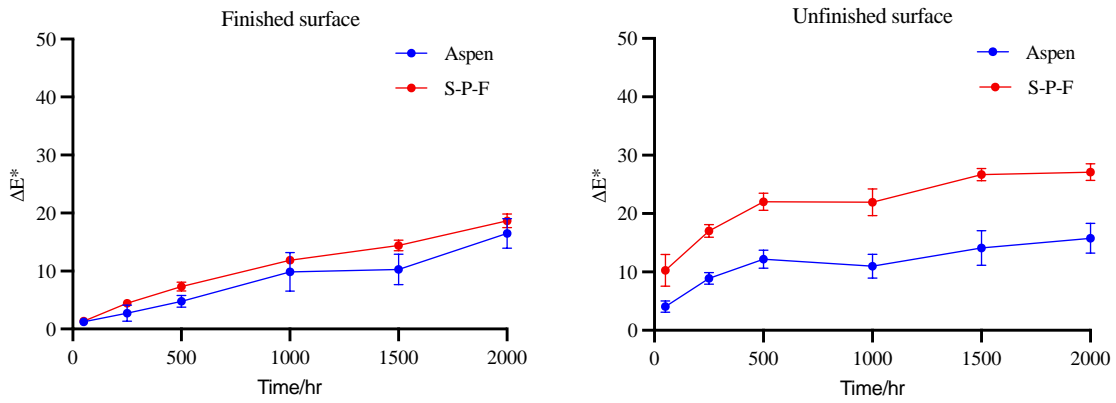
Fig. 9. Variation in ΔE^* over the artificial accelerated weathering treatment.

Fig. 9 presents the colour changes on the surfaces of trembling aspen and S-P-F siding specimens, with and without finishing, over the weathering exposure. As weathering duration increased, the colour variation became more pronounced in both trembling aspen and S-P-F specimens. The overall ΔE in trembling aspen specimens was lower than that in S-P-F ones. For finished aspen siding, the average ΔE increased from 1.2 to 9.9 over the first 1,000 hours, representing an 87.9% change. Between 1,000 and 1,500 hours, ΔE remained relatively stable, followed by a further 40% increase from 1,500 to 2,000 hours. In contrast, the S-P-F specimens exhibited a continuous increase in ΔE throughout 0 to 2,000-hour entire exposure period, rising from 1.3 to 14.4, with a total change of 91.0%. At each time interval, the S-P-F specimens showed greater colour change than the trembling aspen ones, indicating lower colour stability under the same weathering condition.

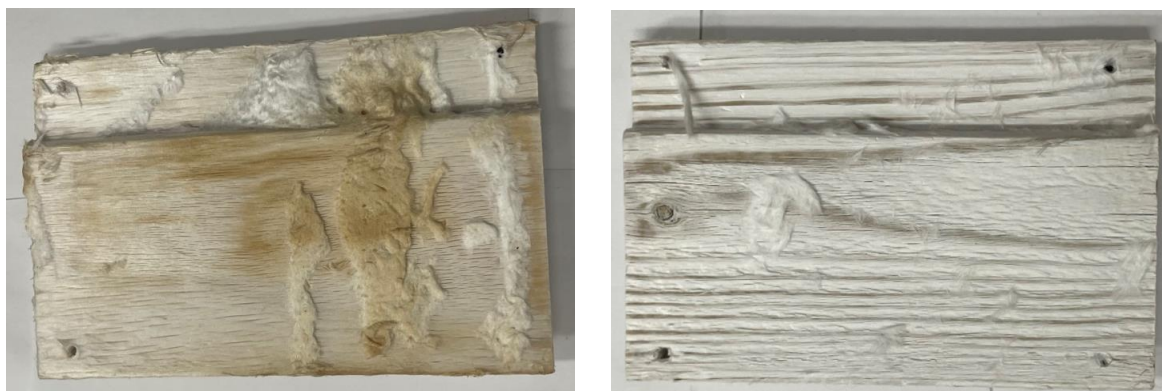
Fig. 11. Surface fibrillation observed after weathering in trembling aspen (left) and S-P-F (right) specimens.

Another notable observation after 1,000 hours of treatment was the presence of varying degrees of fibrillation on the specimens without finishing protection, as shown in **Fig. 11**. This effect was particularly pronounced in unfinished trembling aspen, where localized areas of decay also developed a yellowish discolouration.
